**RADIOLOGICAL CHARACTERIZATION REPORT FOR
FUSRAP PROPERTIES IN THE ST. LOUIS, MISSOURI, AREA**

VOLUME I

MARCH 1990

**K. C. Noey
C. M. Sekula
Bechtel National, Inc.
Oak Ridge, Tennessee**

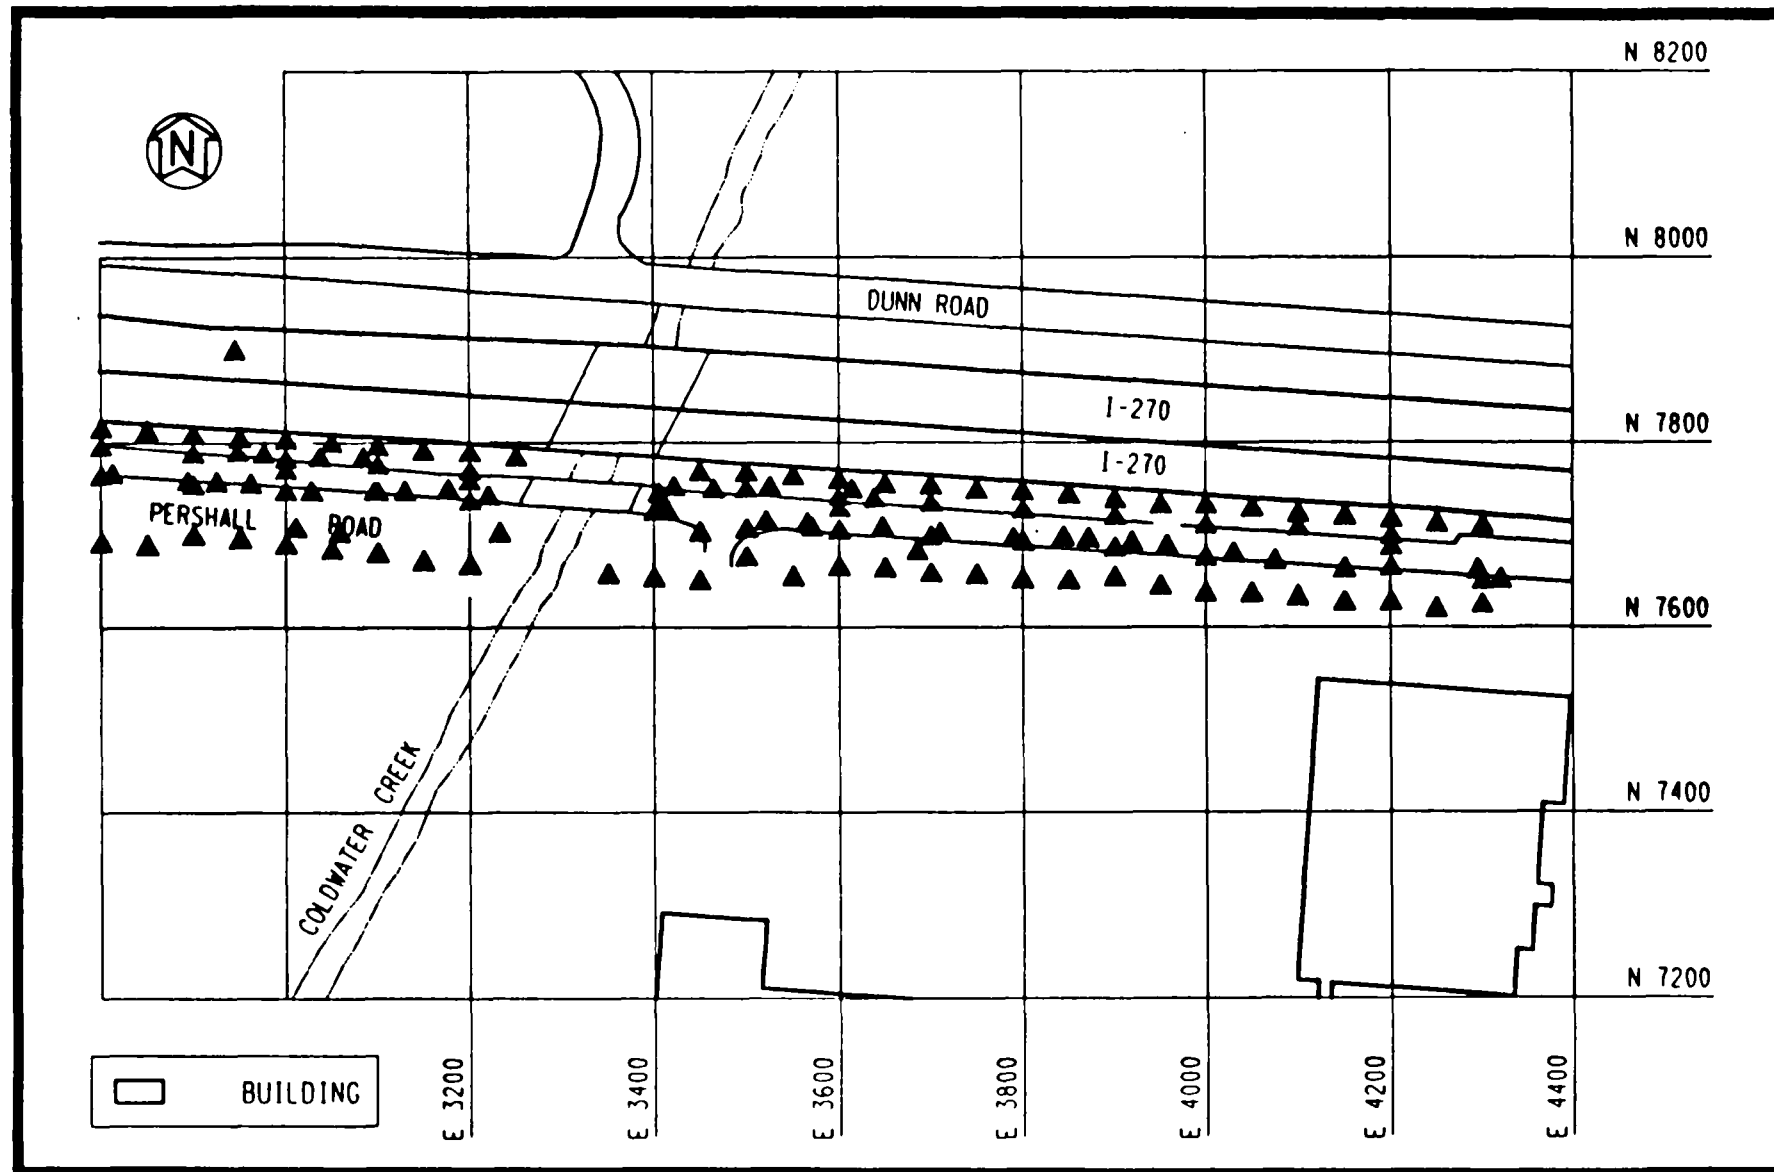
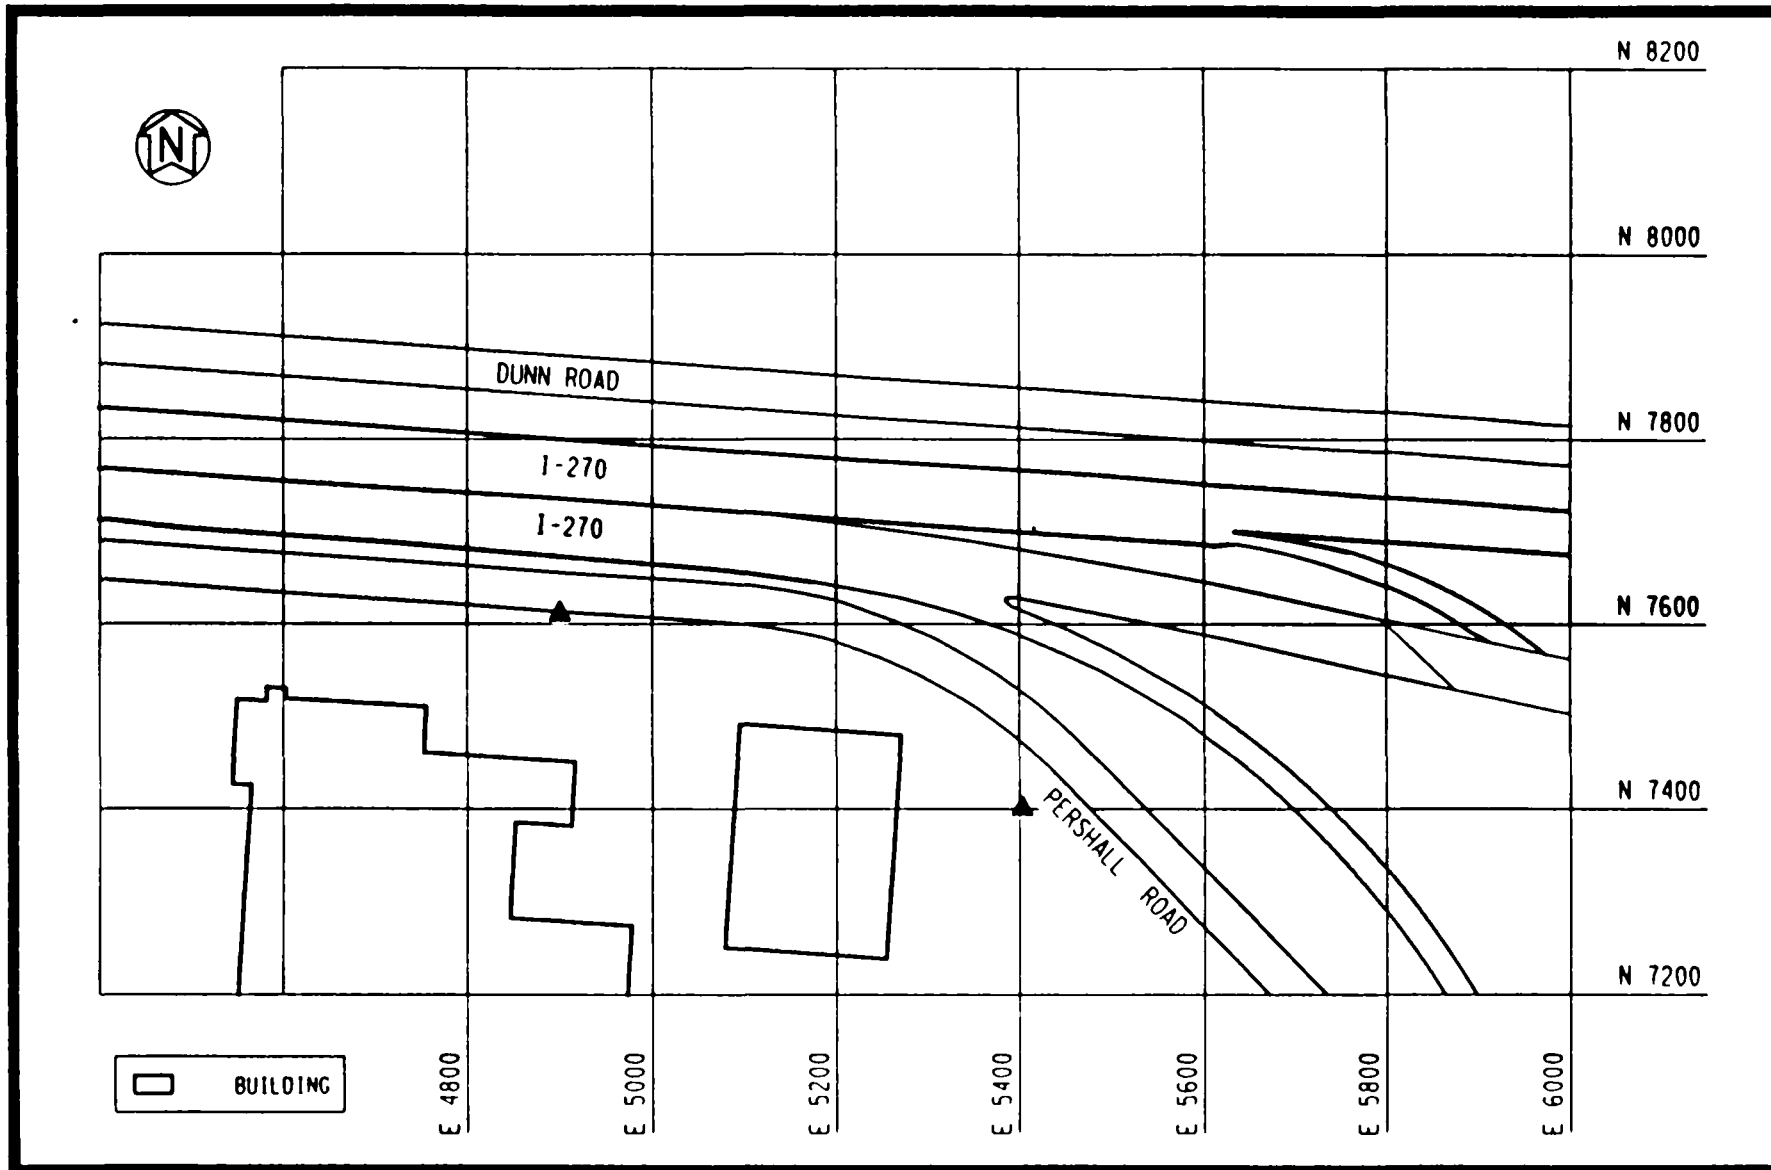
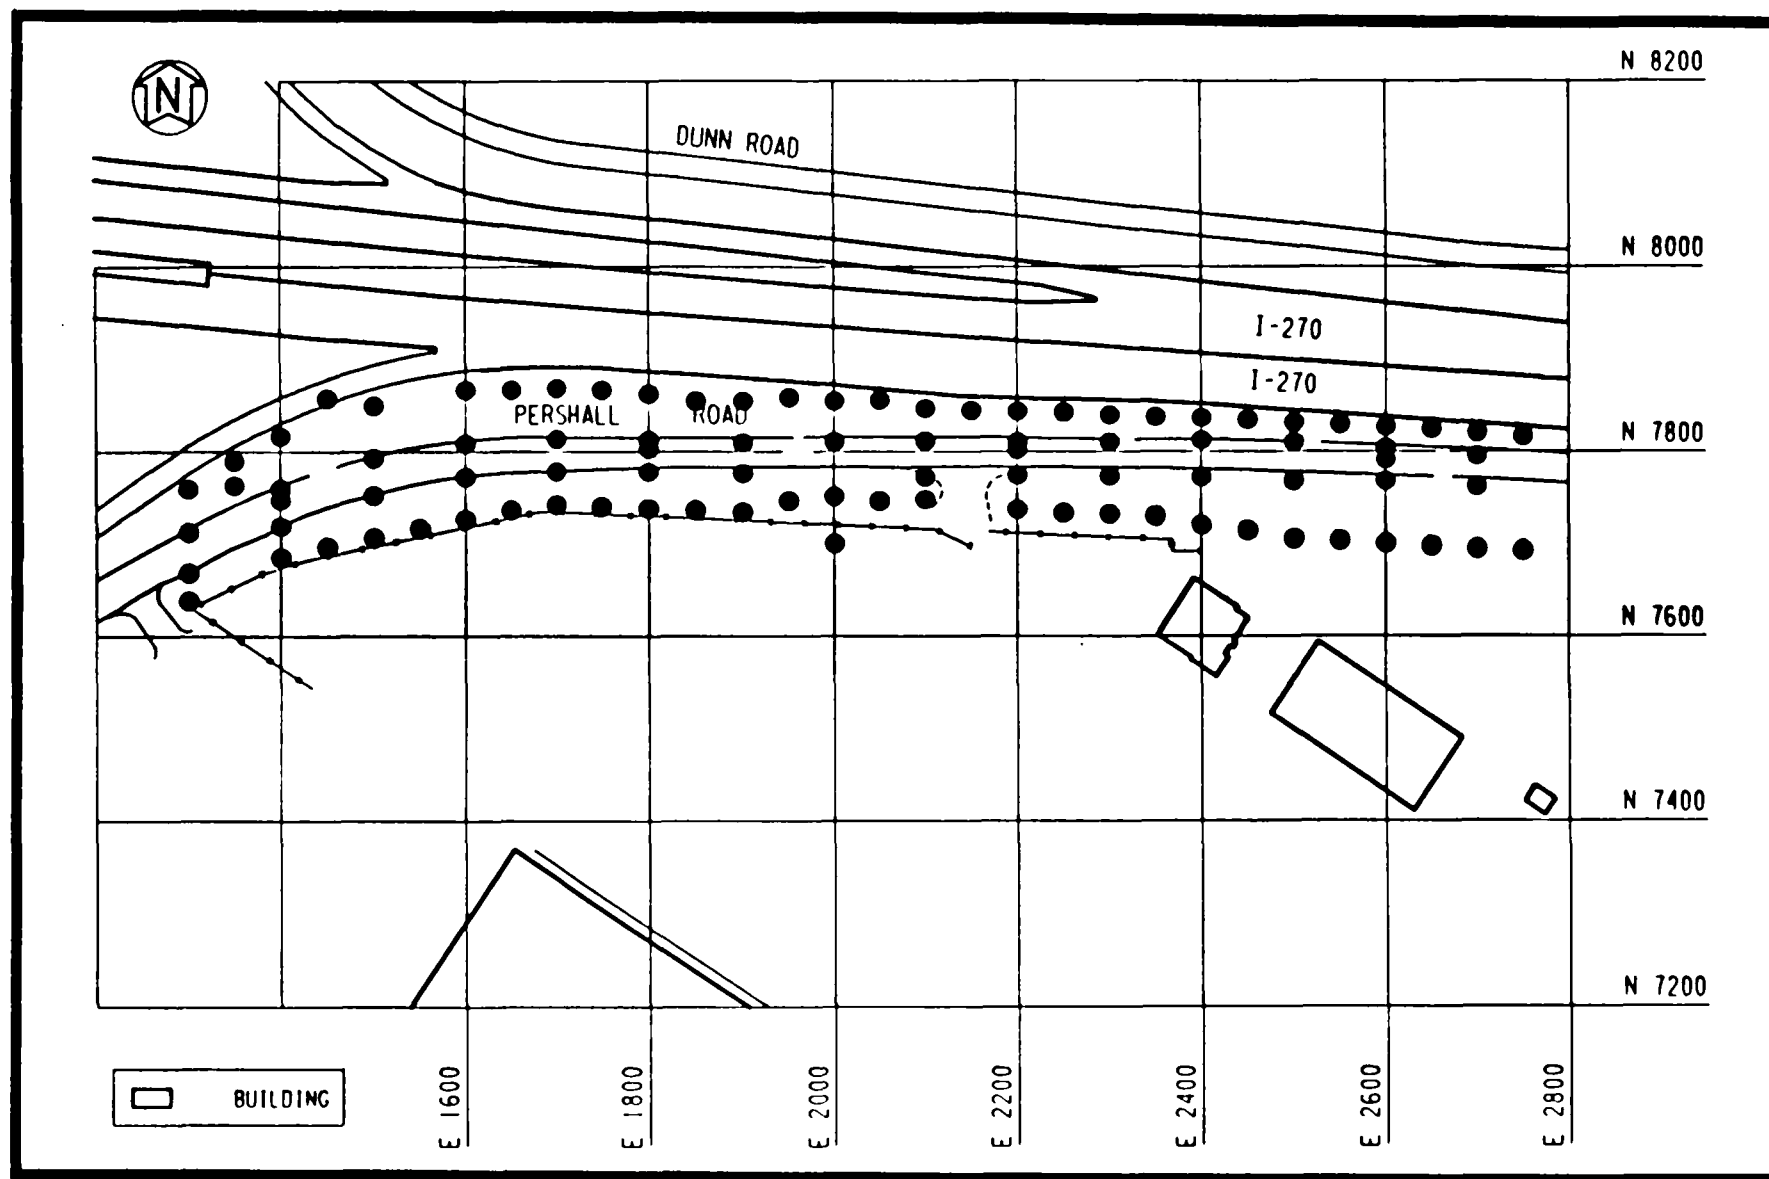
FIGURE 5-13 SURFACE SOIL SAMPLING LOCATIONS FOR RADIOLOGICAL CHARACTERIZATION OF PERSHALL ROAD

Soil sampling locations at Pershall Road are shown in Figures 5-12, 5-13, and 5-14. Analytical results for soil collected at Pershall

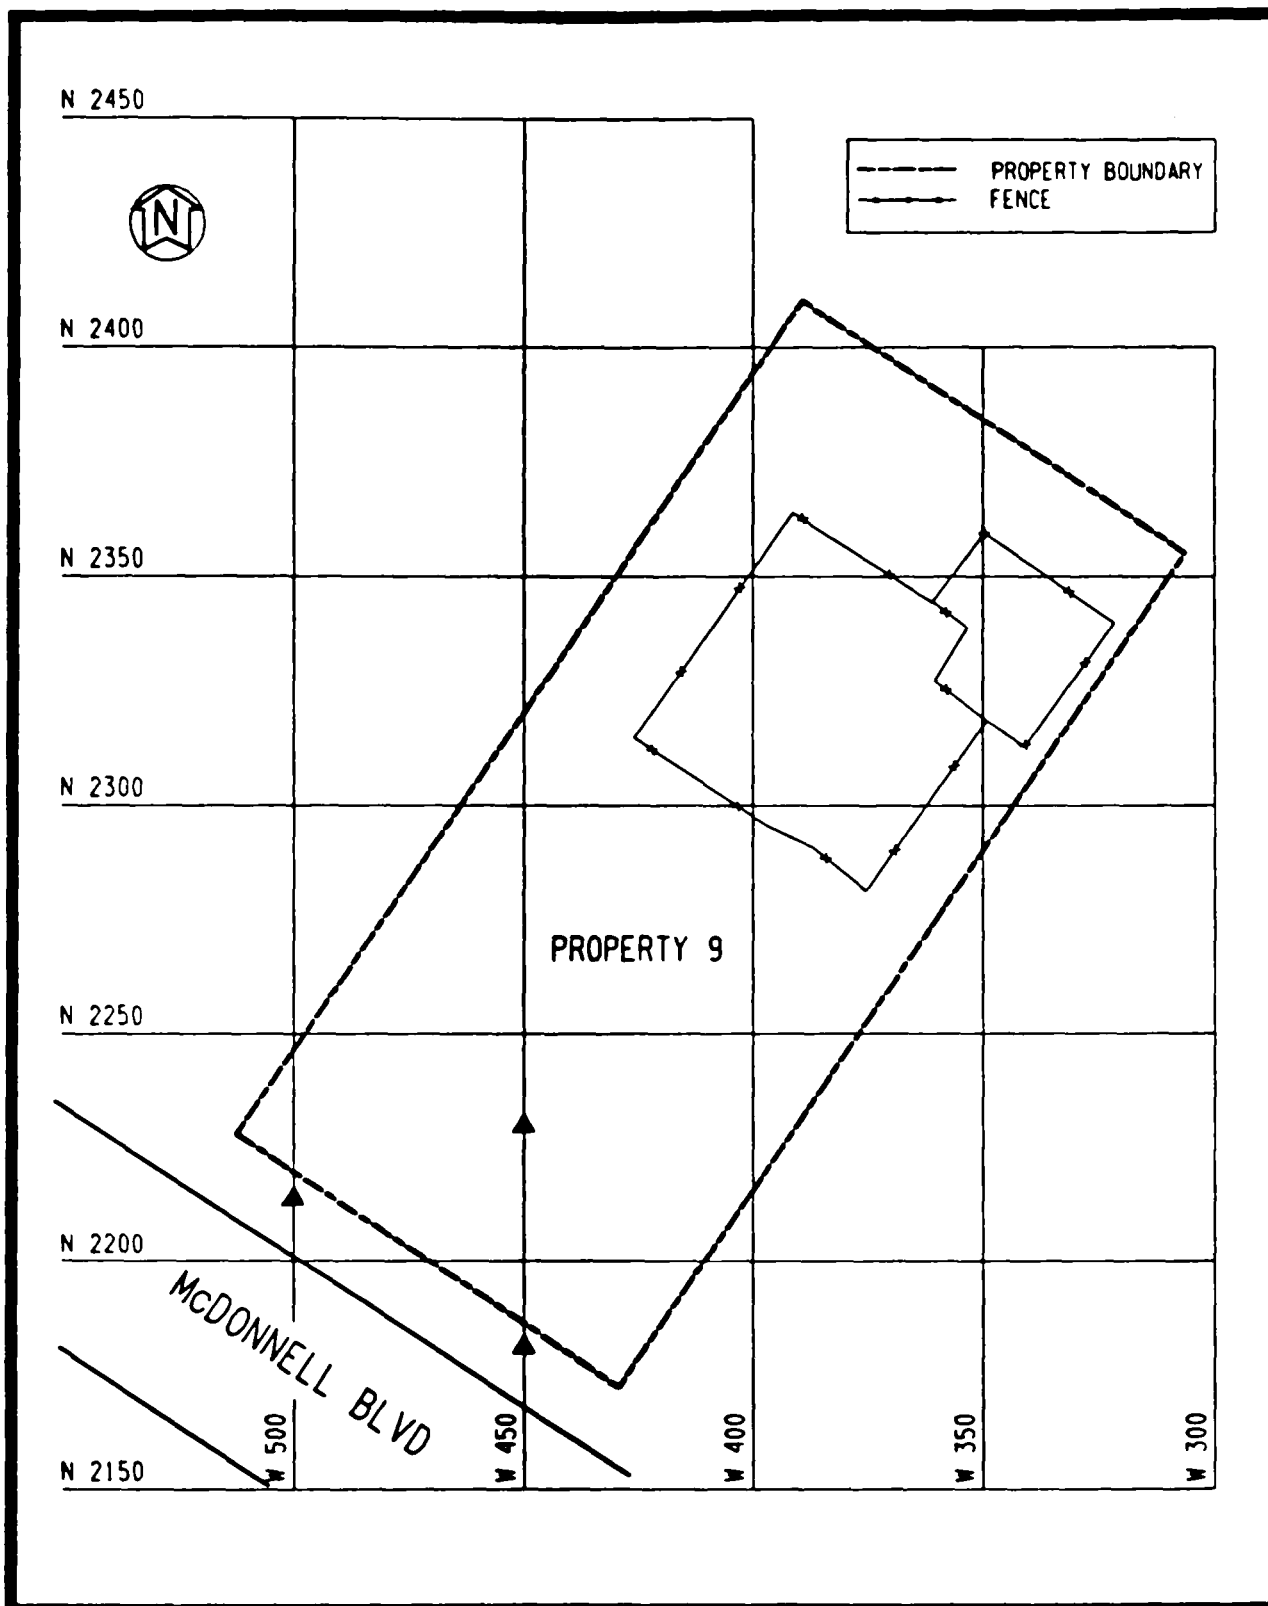
FIGURE 5-25 SOIL SAMPLING LOCATIONS FOR RADIOLOGICAL CHARACTERIZATION OF HAUL ROADS VICINITY PROPERTY 9

Property 9 is located on McDonnell Boulevard. Soil sampling locations augered at Property 9 are shown in Figure 5-25.

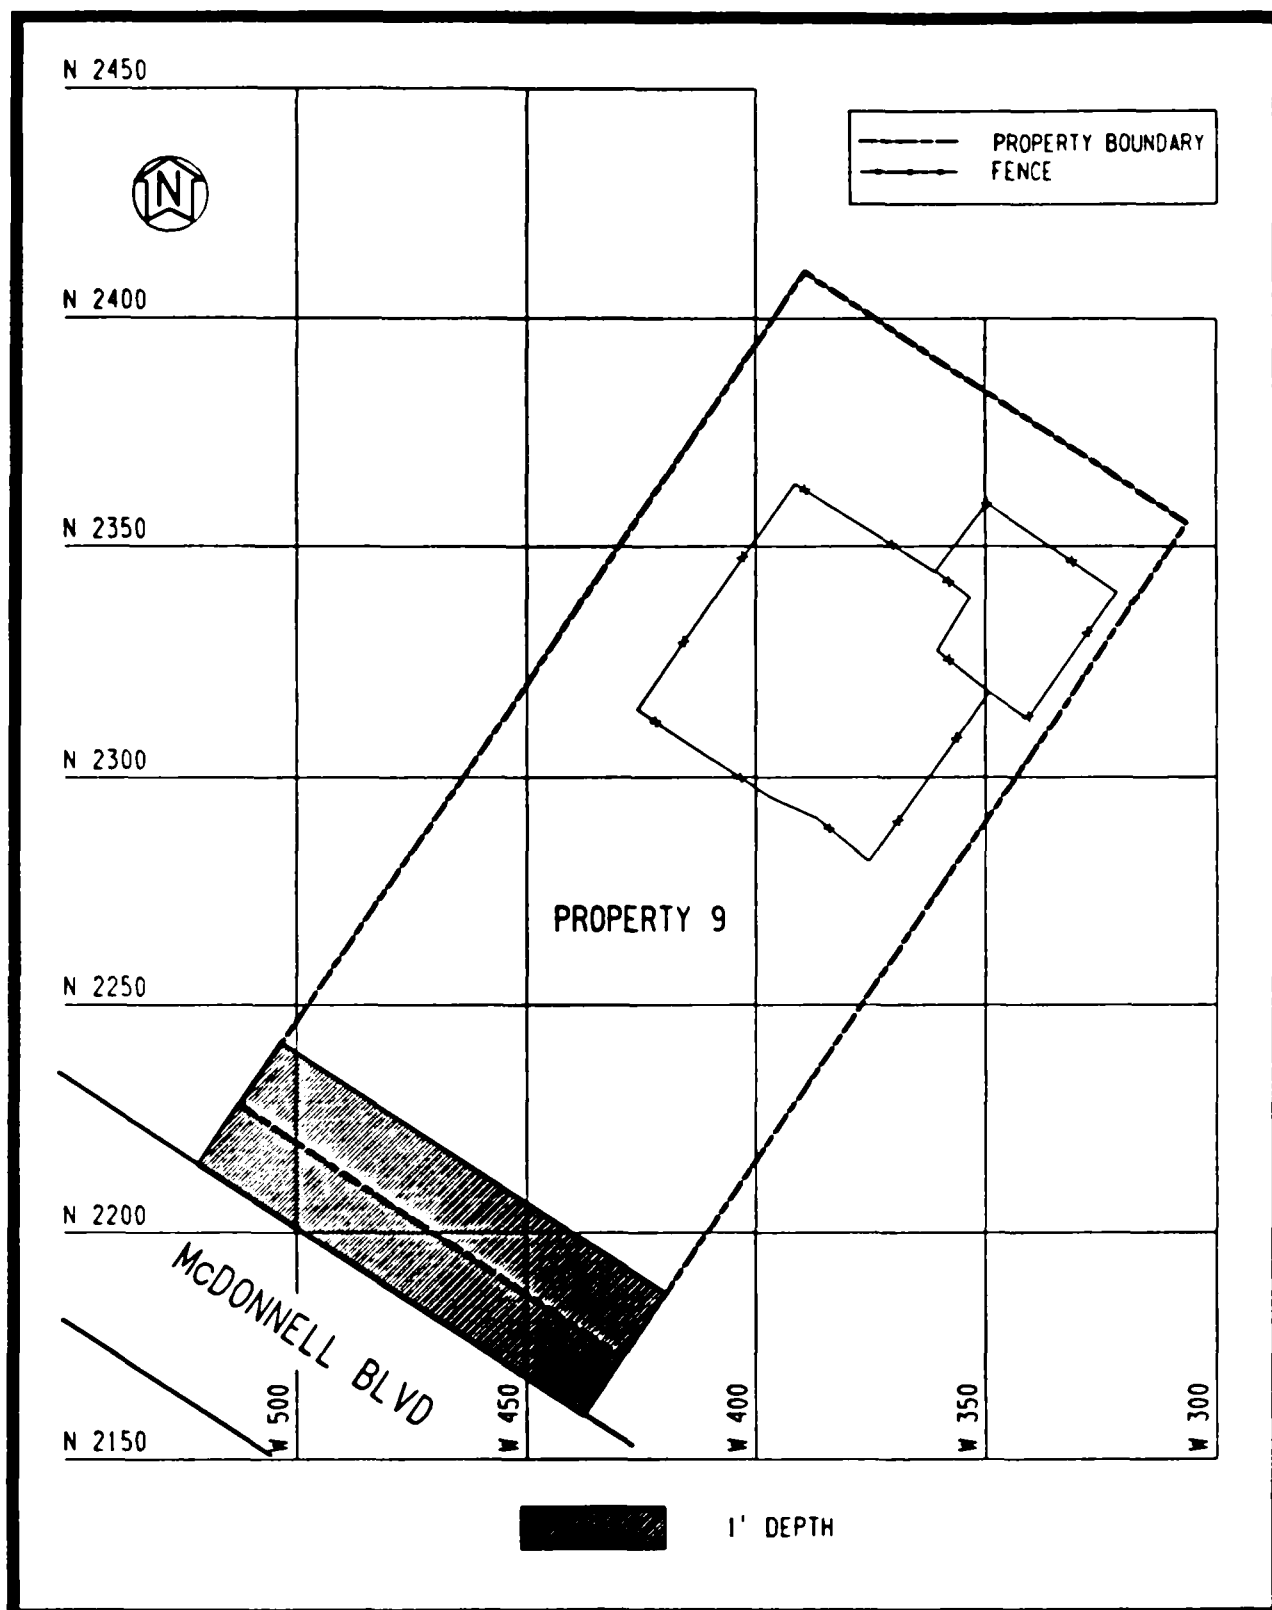
FIGURE 5-26 AREAS AND DEPTHS OF RADIOACTIVE CONTAMINATION AT HAUL ROADS VICINITY PROPERTY 9

Analytical results for soil, provided in Table 5-16, revealed elevated concentrations of thorium-230 at two locations. Areas and depths of thorium-230 contamination are shown in Figure 5-26. Before remedial action begins, additional soil samples will be collected and analyzed from this property to more accurately define contamination boundaries. Figure 5-26 depicts a conservative estimate of contamination boundaries.

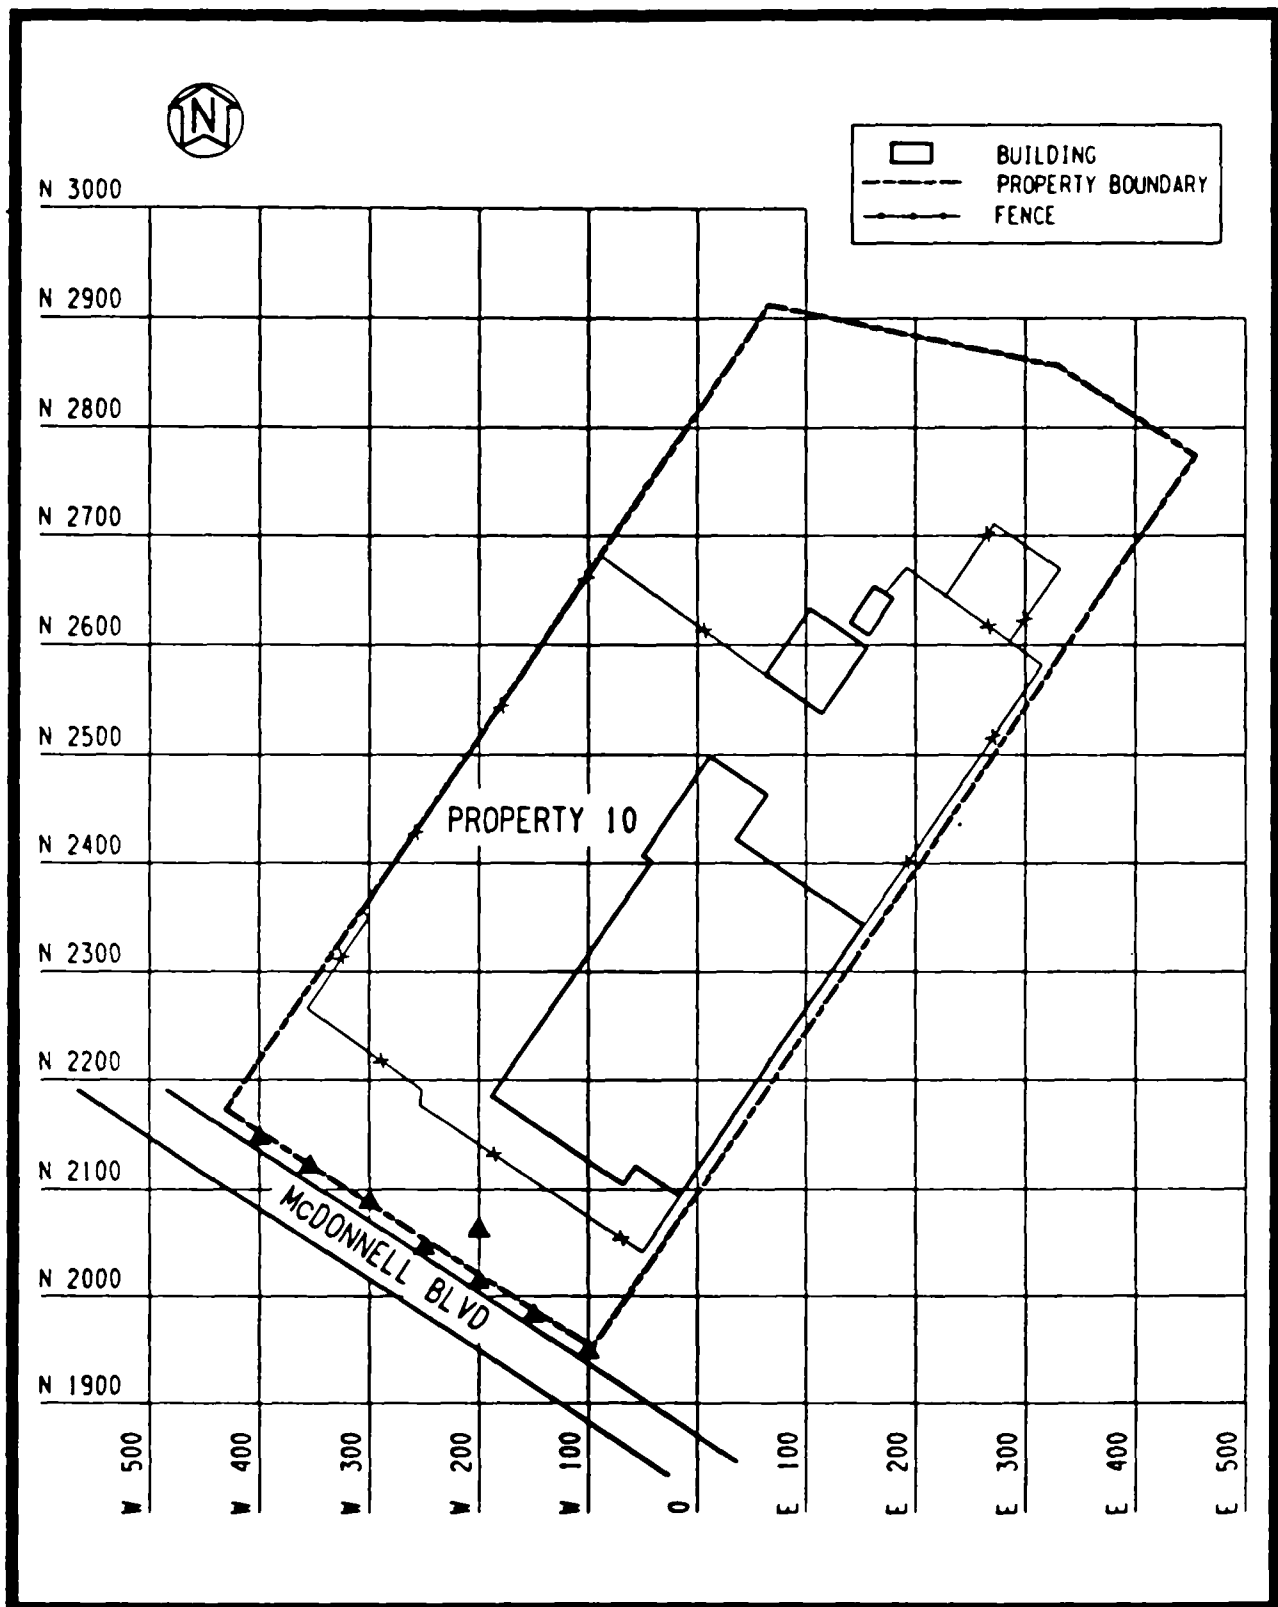
FIGURE 5-27 SOIL SAMPLING LOCATIONS FOR RADIOLOGICAL CHARACTERIZATION OF HAUL ROADS VICINITY PROPERTY 10

Property 10 is located on McDonnell Boulevard. Locations from which soil samples were collected and analyzed are shown in Figure 5-27. Analytical results for soil (Table 5-17) revealed one area with an elevated concentration of thorium-230. Thorium-230 concentrations ranged from 1.2 to 7.2 pCi/g. Areas and depths of thorium-230 contamination at Property 10 are shown in Figure 5-28.

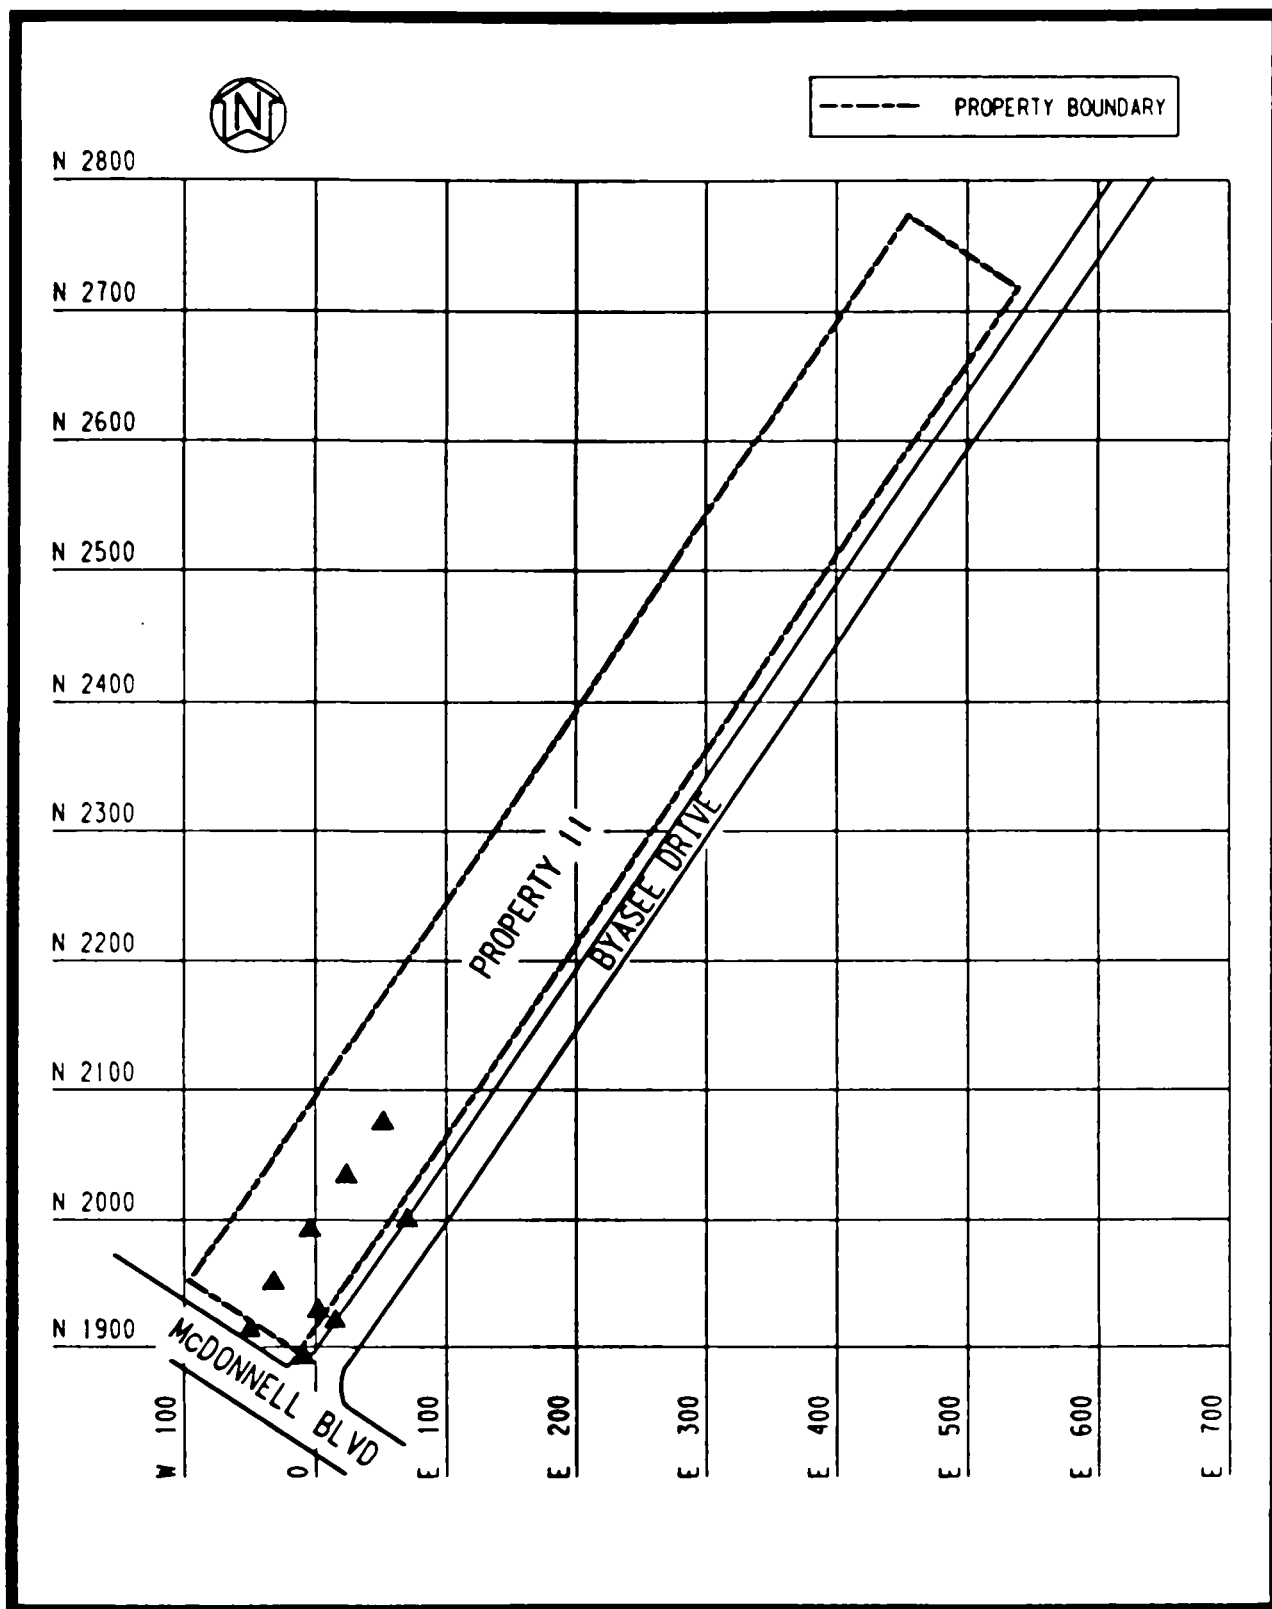
FIGURE 5-29 SOIL SAMPLING LOCATIONS FOR RADIOLOGICAL CHARACTERIZATION OF HAUL ROADS VICINITY PROPERTY 11

Property 11 is bordered by McDonnell Boulevard on the south and Byassee Drive on the east. Locations from which soil samples were collected and analyzed are shown in Figure 5-29. Analytical results for soil (Table 5-18) revealed two areas with elevated concentrations of thorium-230, which ranged from less than 0.8 to 18 pCi/g. Areas and depths of thorium-230 contamination at Property 11 are shown in Figure 5-30.

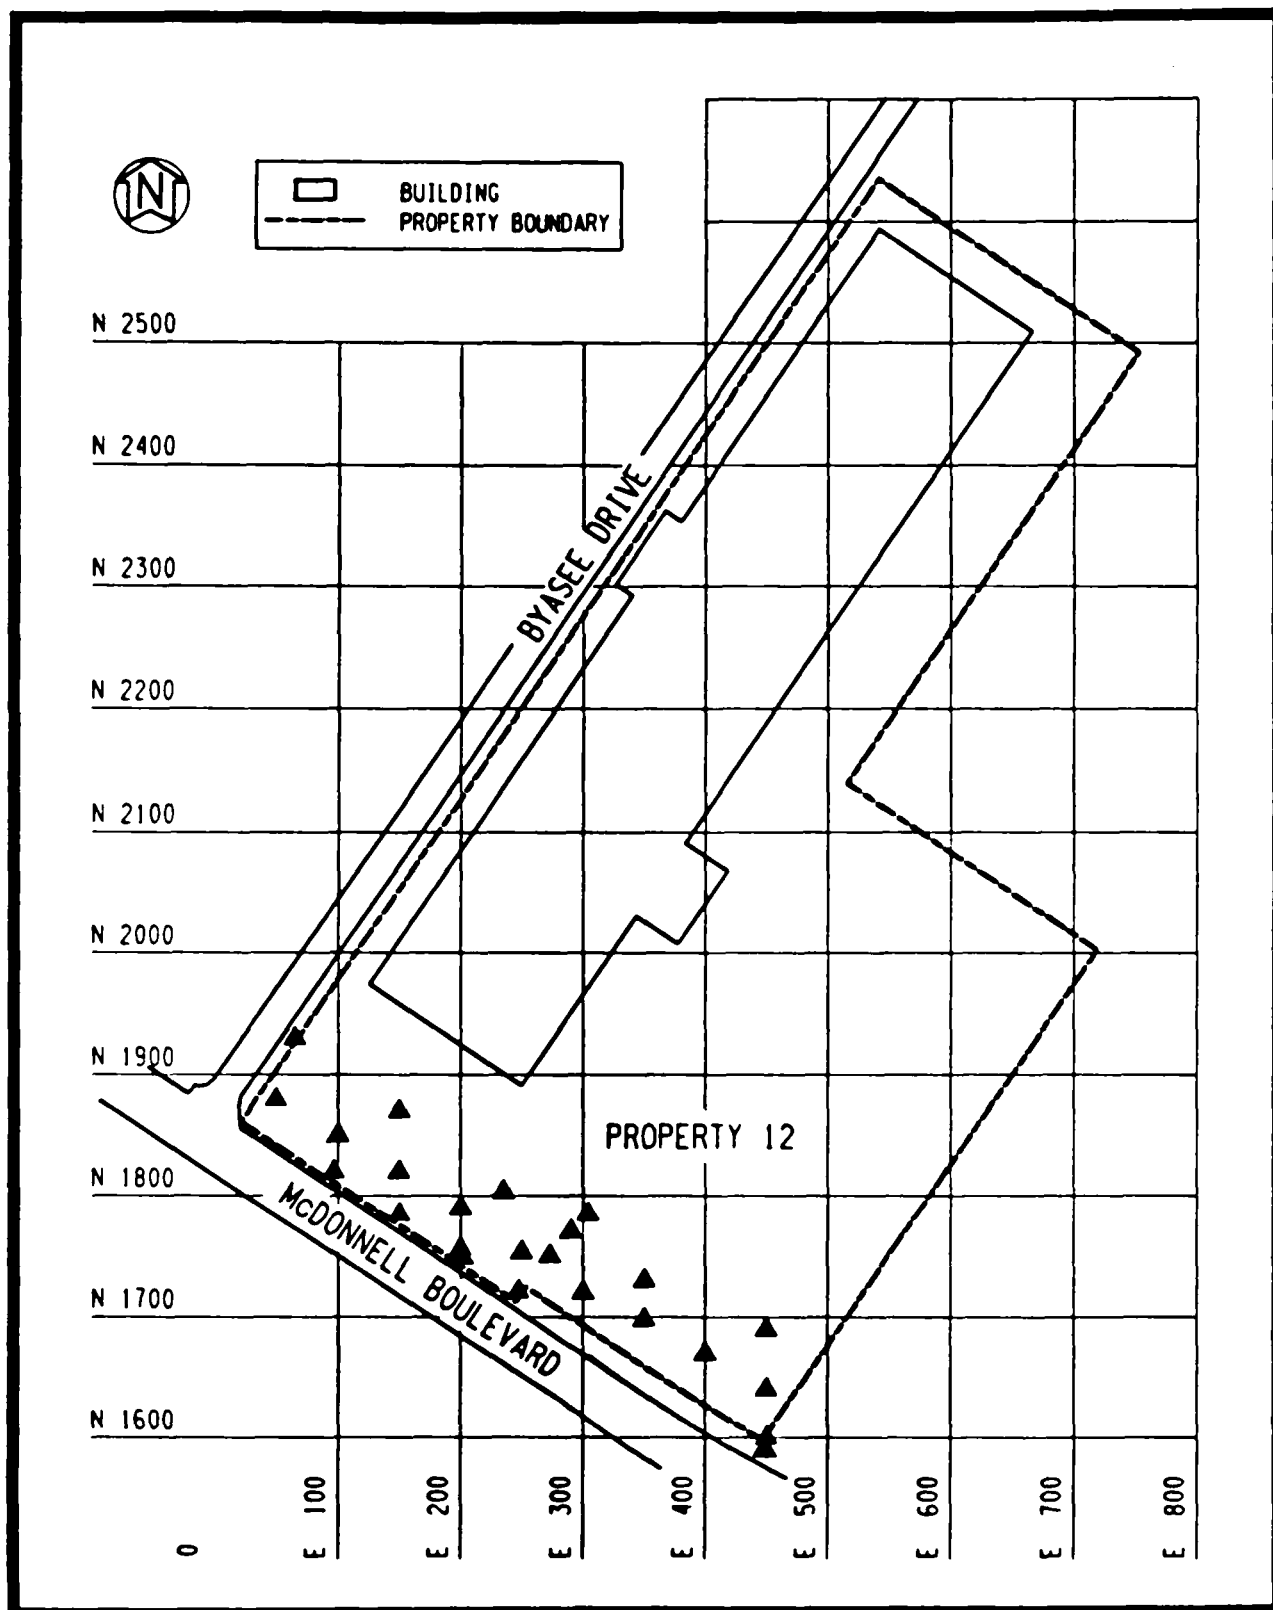
FIGURE 5-31 SOIL SAMPLING LOCATIONS FOR RADIOLOGICAL CHARACTERIZATION OF HAUL ROADS VICINITY PROPERTY 12

included a walkover gamma scan and collection and analysis of 54 soil samples for uranium-238, radium-226, thorium-232, and thorium-230. Soil sampling locations on Property 12 are shown in Figure 5-31. Analytical results for (Table 5-19) soil revealed elevated concentrations of radium-226 and thorium-230 in surface and subsurface samples. All uranium-238 concentrations were less than 19 pCi/g. Radium-226 concentrations ranged from 0.6 to 13 pCi/g. Concentrations of thorium-232 and thorium-230 ranged from 0.7 to 5 pCi/g and from less than 1 to 570 pCi/g, respectively. Soil samples collected during the 1989 characterization effort at the haul roads were analyzed for thorium-230 only; therefore, there are no results reported for uranium-238, radium-226, or thorium-232 in Table 5-19. Further soil sampling is required before boundaries of radioactive contamination can be established at Property 12. This sampling will occur before remedial action begins.

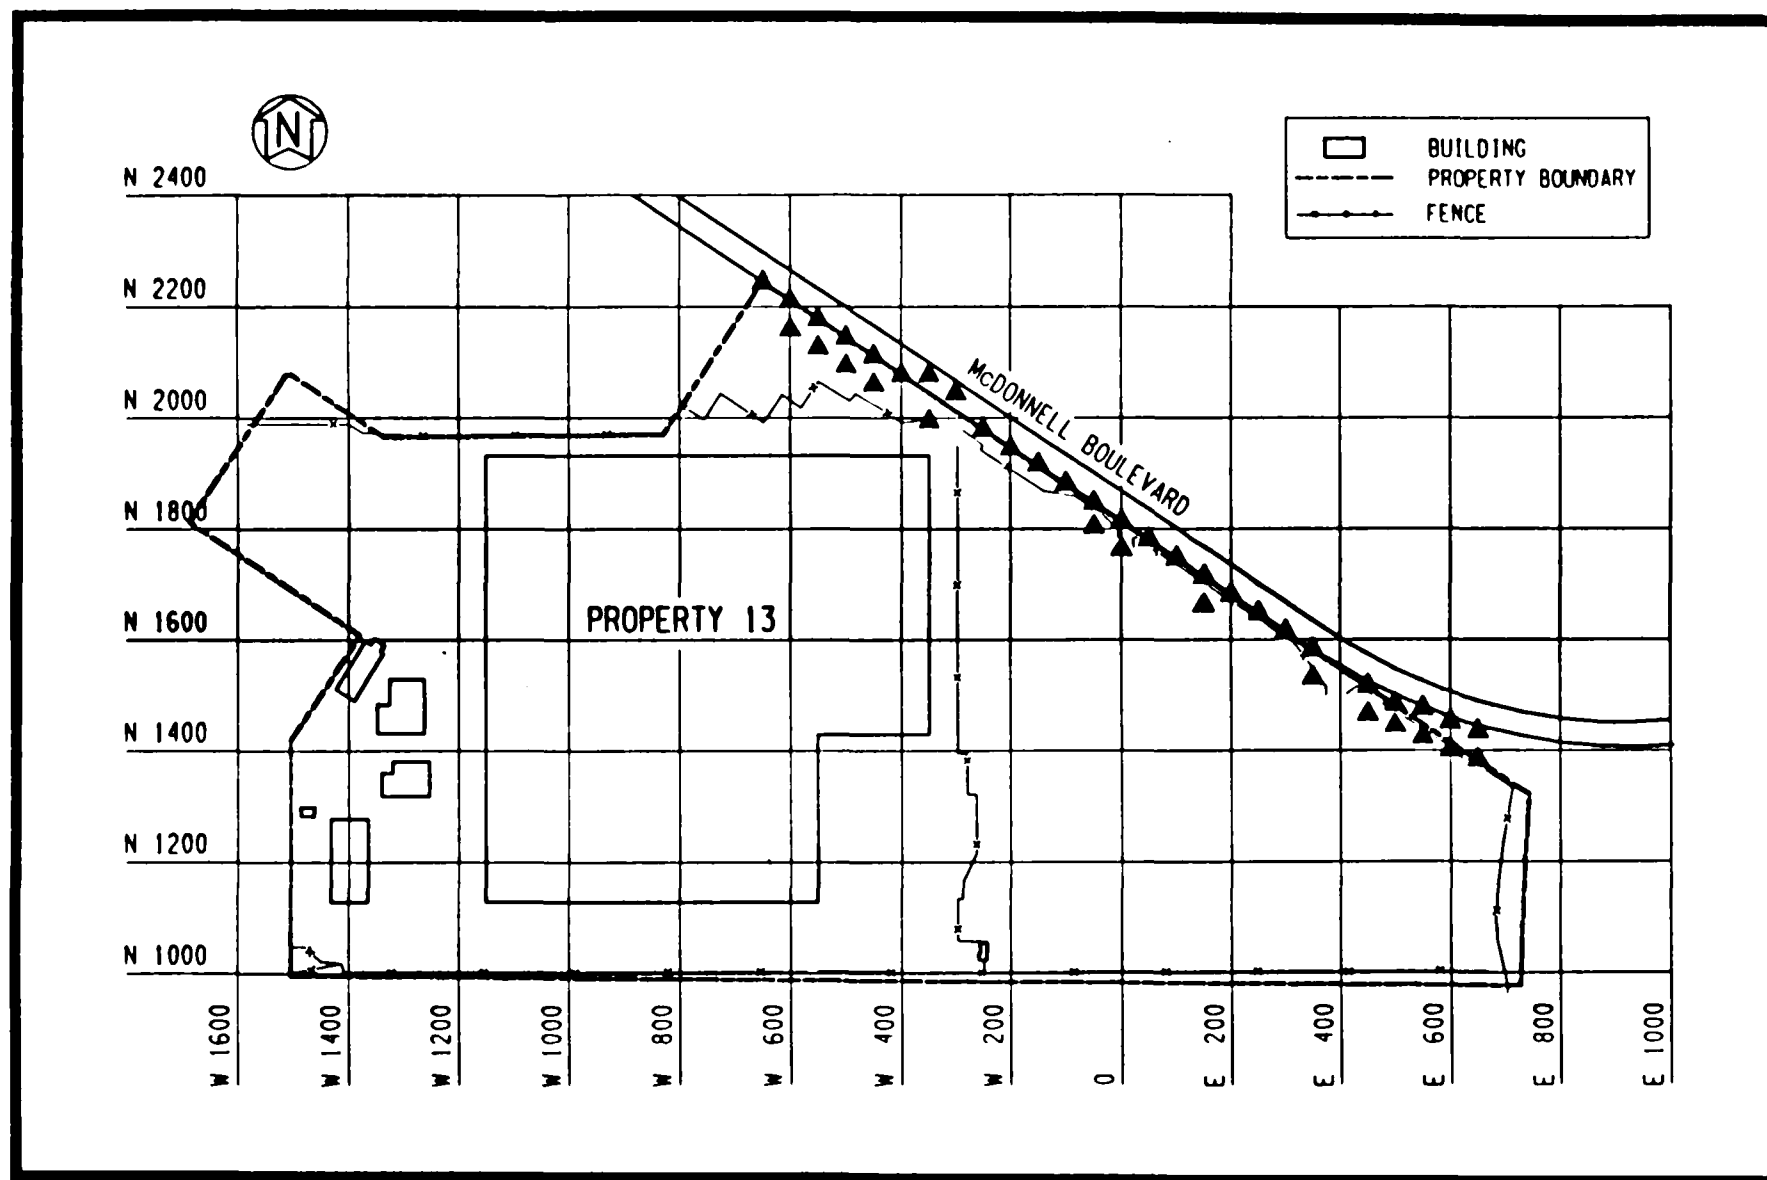
FIGURE 5-32 SOIL SAMPLING LOCATIONS FOR RADIOLOGICAL CHARACTERIZATION OF HAUL ROADS VICINITY PROPERTY 13

Property 13 is located on McDonnell Boulevard. Locations from which soil samples were collected and analyzed are shown in Figure 5-32. Analytical results for soil (Table 5-20) revealed 14 areas with elevated concentrations of thorium-230, which ranged from less than 0.7 to 370 pCi/g. Additional soil sampling is required before boundaries of radiological contamination can be determined at Property 13. This sampling will take place before remedial action begins.

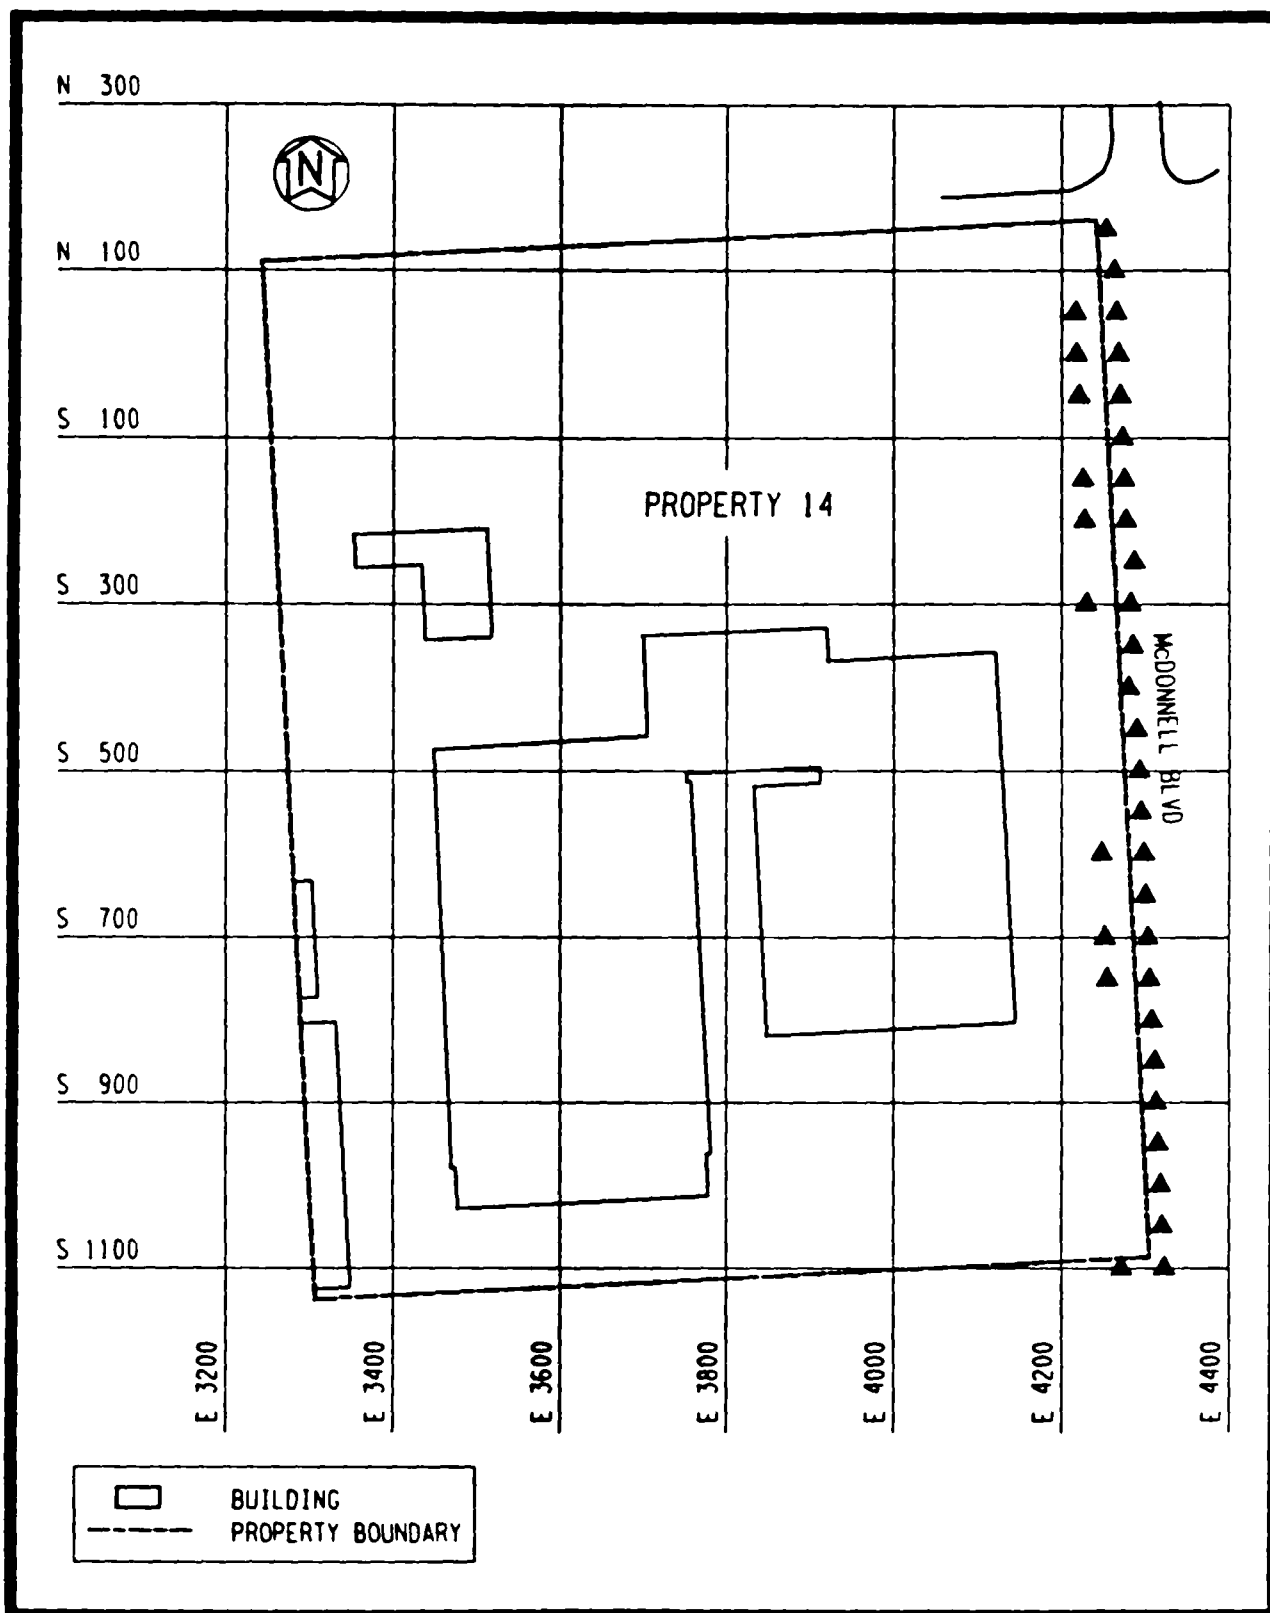
FIGURE 5-33 SOIL SAMPLING LOCATIONS FOR RADIOLOGICAL CHARACTERIZATION OF HAUL ROADS VICINITY PROPERTY 14

shown in Figure 5-33. Analytical results for soil (Table 5-21) revealed 10 areas exhibiting elevated concentrations of thorium-230, which ranged from less than 0.9 to 33 pCi/g. Areas and depths of radioactive contamination at Property 14 are shown in Figure 5-34.
